Use of Asphalt Reinforcement in Heavily Loaded Container Terminal Pavements

GEOANZ #1

ADVANCES IN GEOSYNTHETICS
7-9 JUNE 2022 | BRISBANE CONVENTION & EXHIBITION CENTRE

JP Theron | BEng Civil, BSc Agric
Business Development Manager – QLD
Roads & Pavements
HUESKER Australia

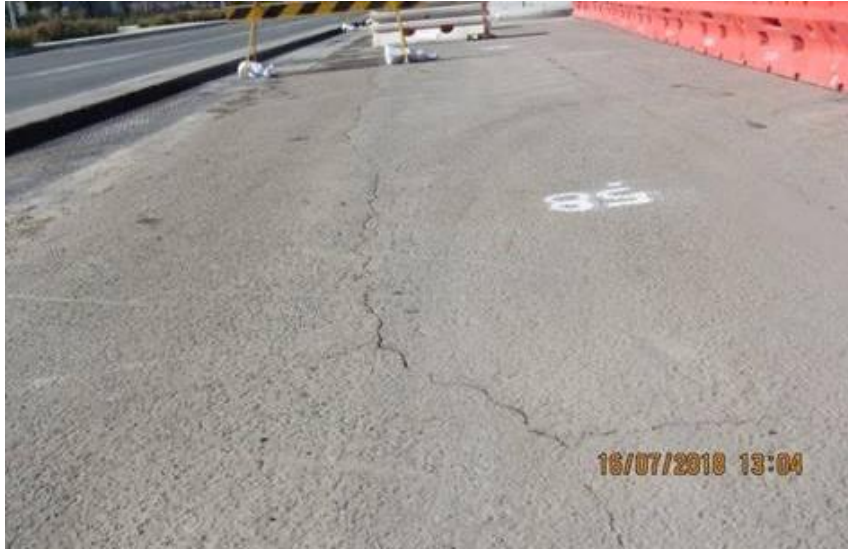
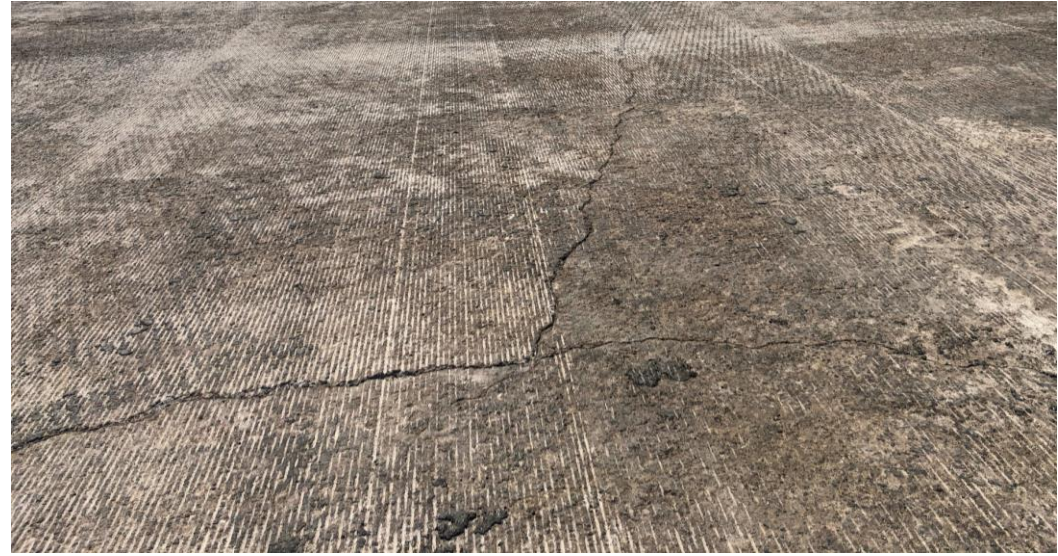
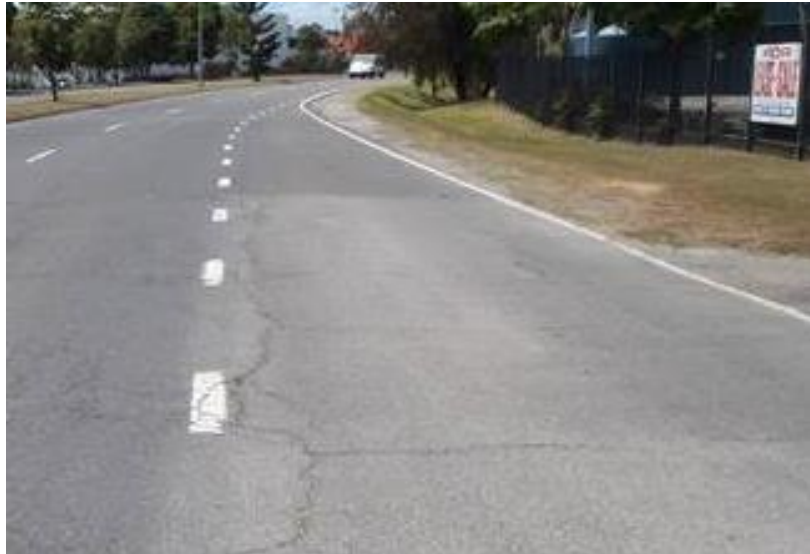
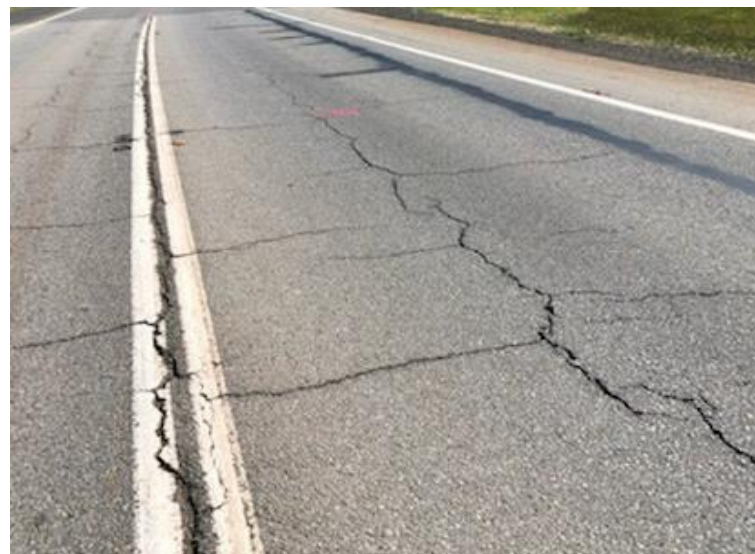
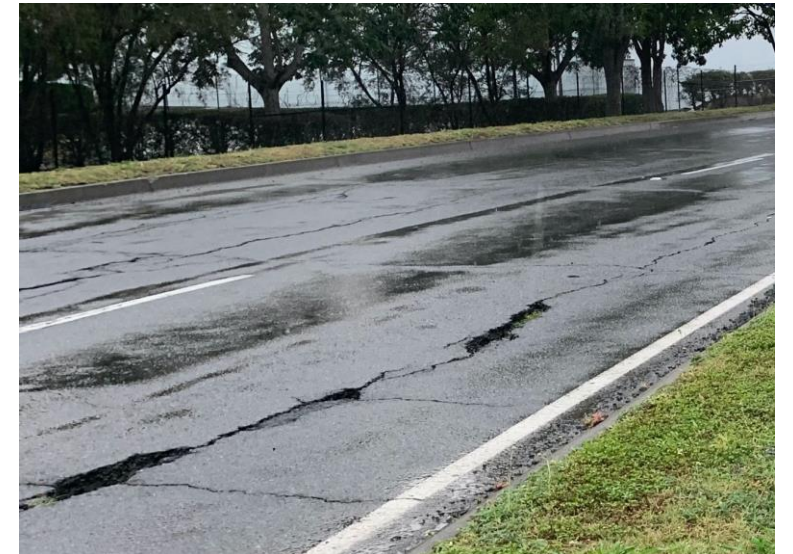
Shrinkage cracking in CTB & Reflective cracking in Asphalt

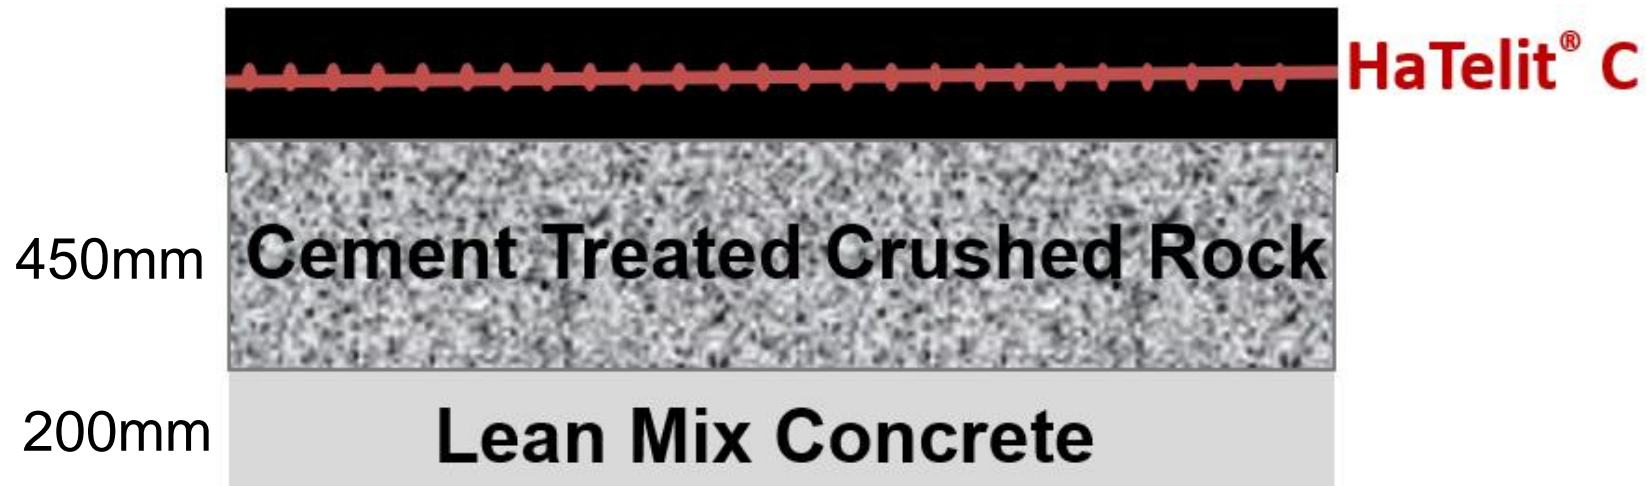
- # Taxiway K constructed in 2004/05 as asphalt surfaced flexible pavement
- # Extensive repeated failures in 2010 and 2013 led to reconstruction in 2016
- # Pavement design solution was reconstruction of the pavement with HaTelit C incorporated into 100mm asphalt overlay over CTB (450mm thick).

Source: Adelaide Airport & Aurecon: Taxiway Kilo 2016 Reconstruction Pavement Detail

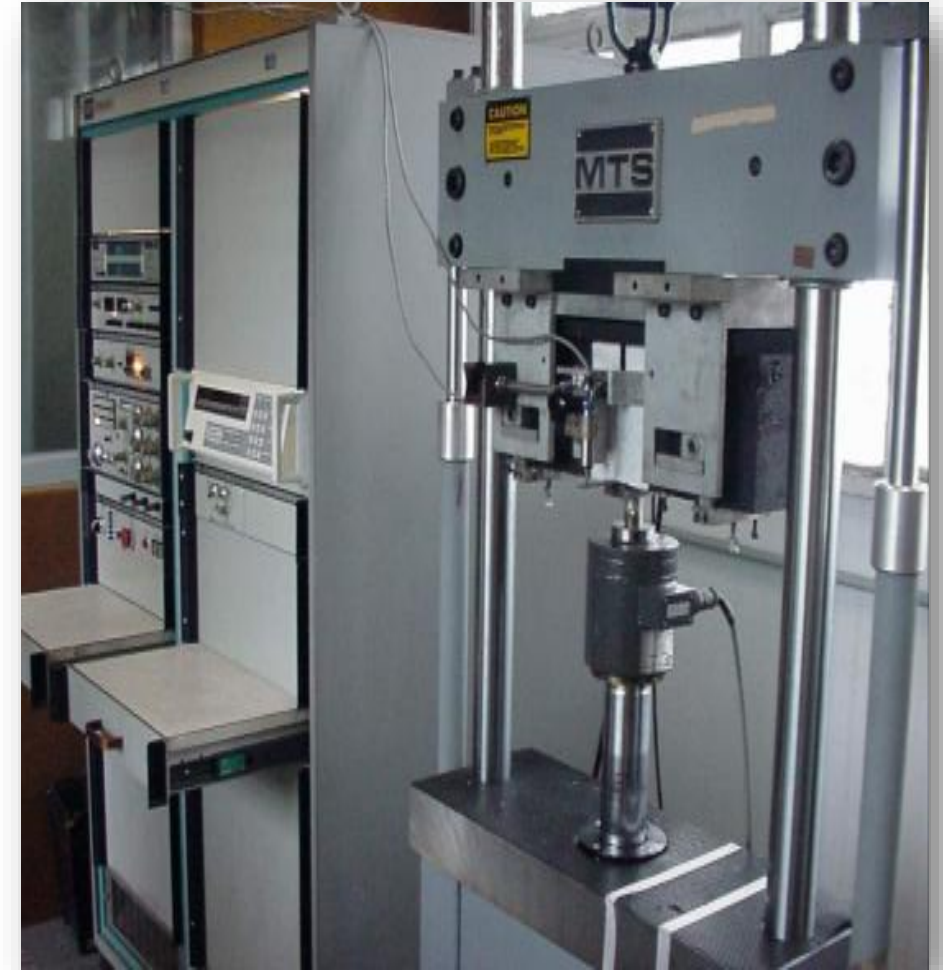
Material	HaTelit ® C
Precrack	3mm, 6mm, 9mm
HaTelit ® Position	Directly above the crack tip
Load Position	Bending and Shear mode
Contact Pressure	560 kN/m ² (max value)

- (1) Overlay
- (2) Blocks with opening
- (3) Elastic base (rubber)

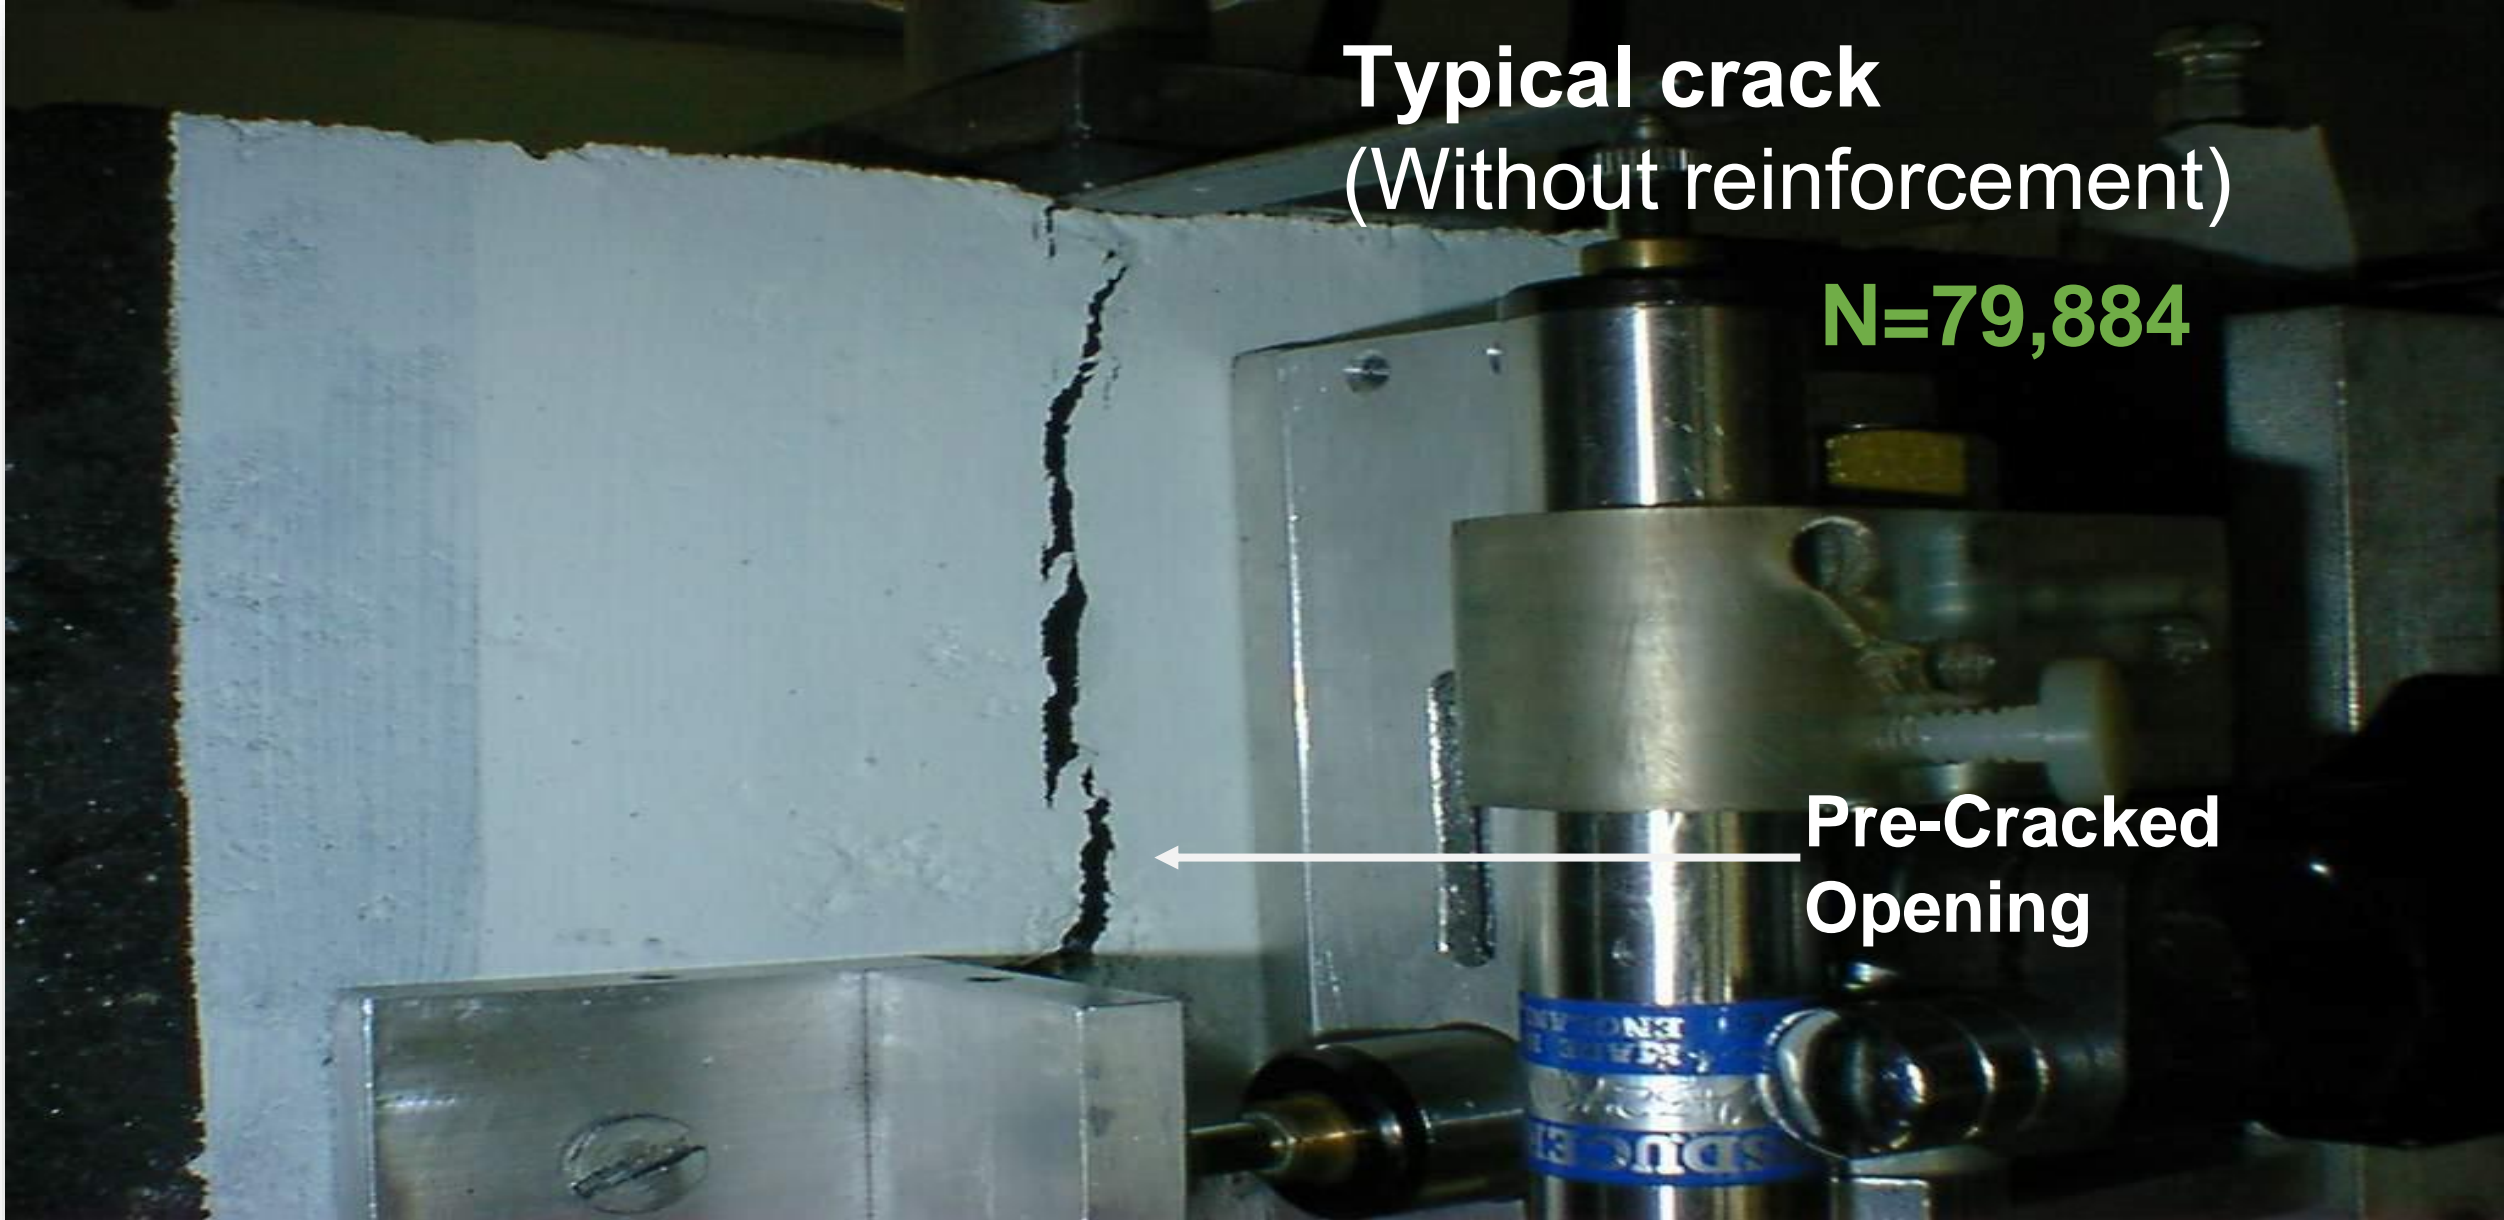
Typical cracking without reinforcement

Typical crack
(Without reinforcement)

N=79,884

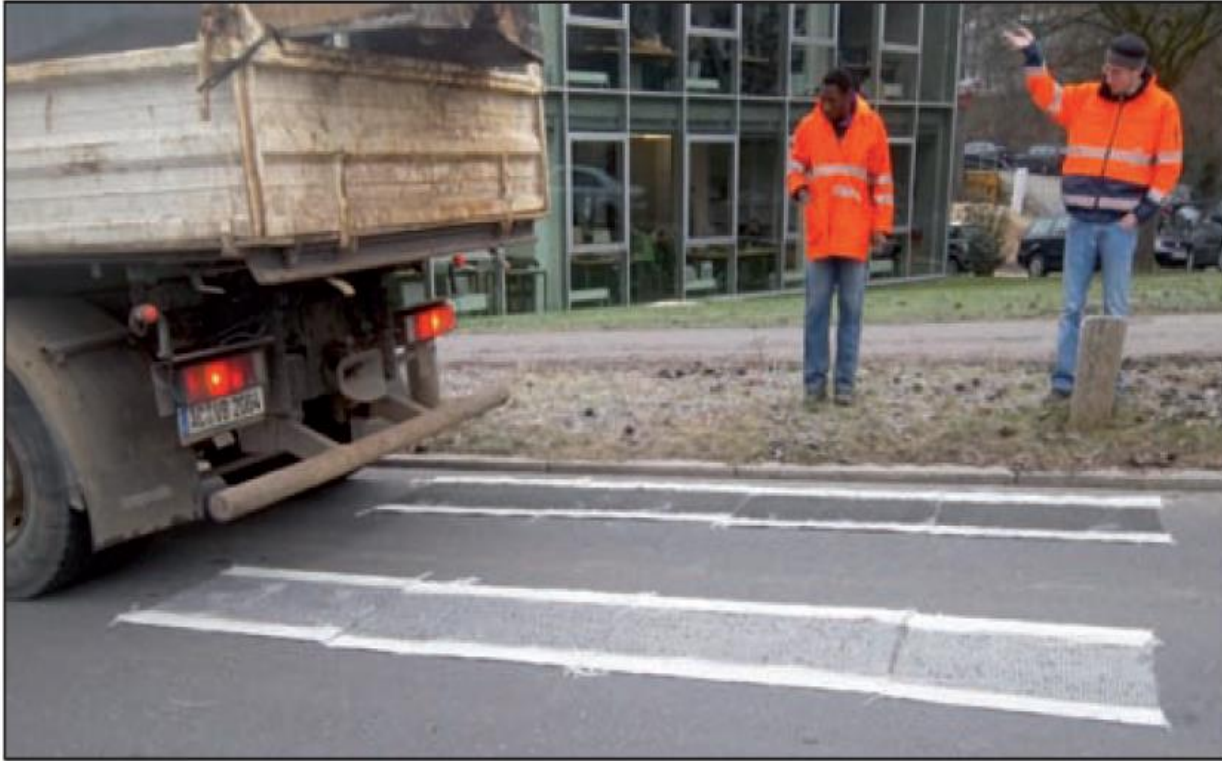
- # 35 passes with a 2 axle truck
- # Corresponds to 7 semi trailers passes

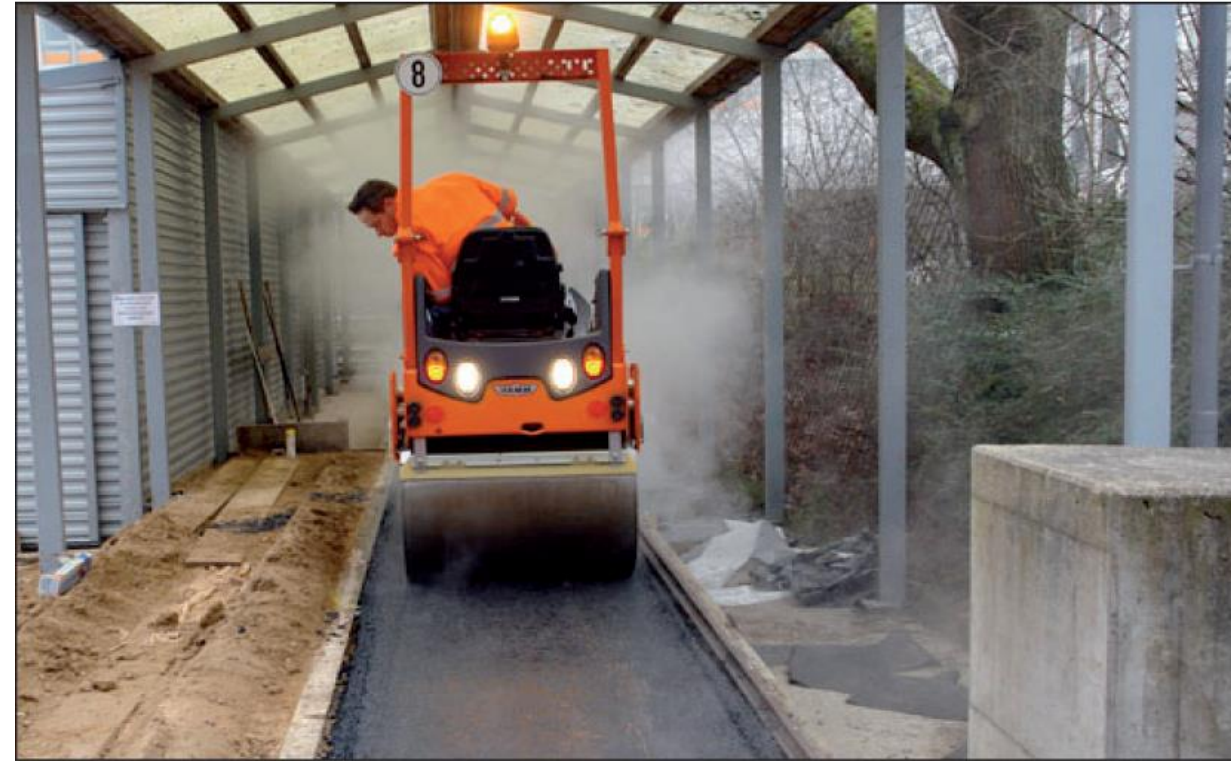
- # 6 roller passes

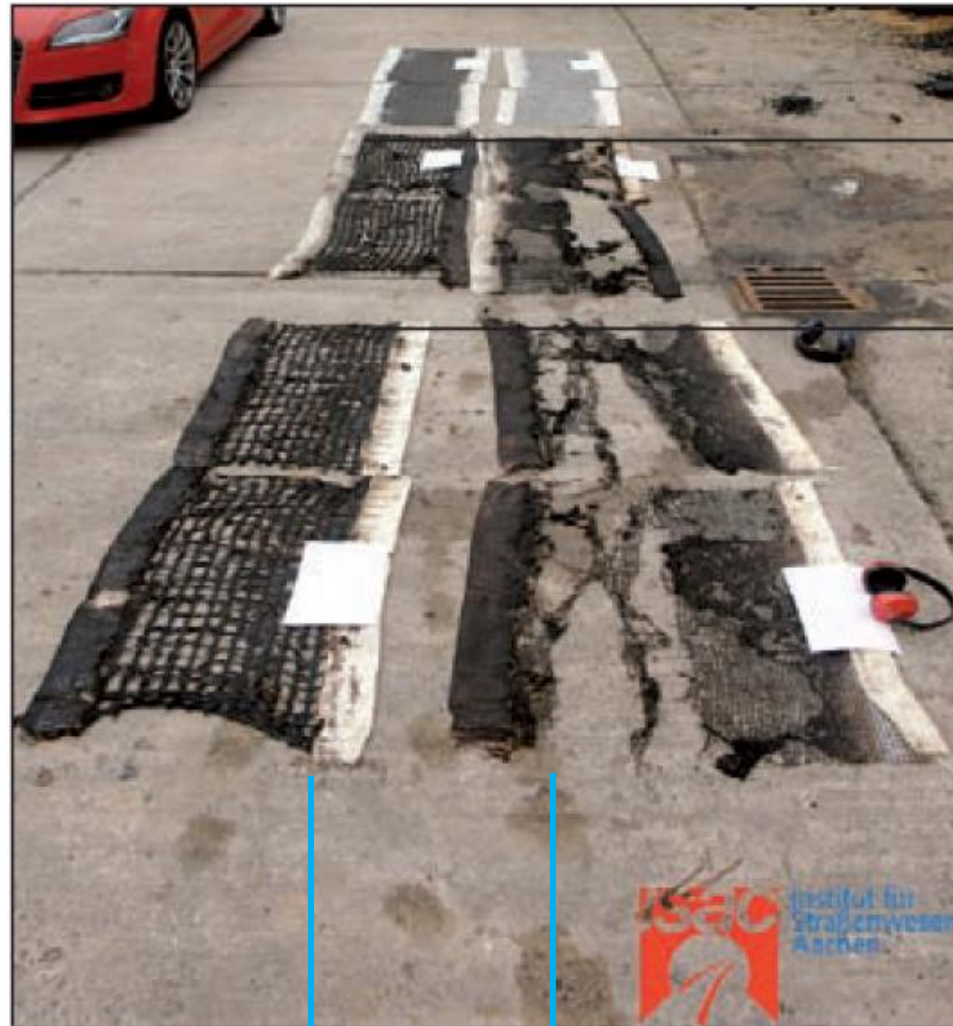
- # There is a considerable difference between the influence of trucks passes and asphalt compaction
- # Significant damage and loss of strength in the grid made from glass-fibres (Right), contrary to PET HaTelit C reinforcement (Left)

Only truck passes

Only compaction

Combination

PET (HaTelit C) asphalt reinforcement

Glass-fibre asphalt reinforcement

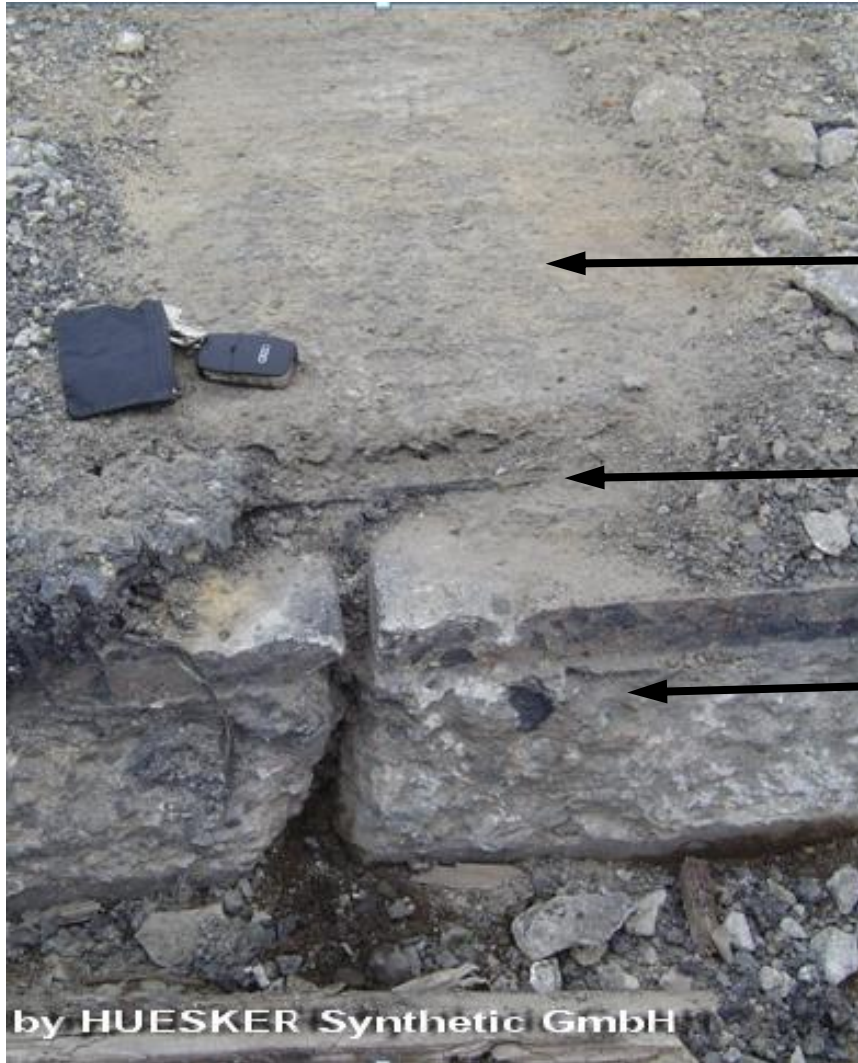
15 years after rehabilitation, in service with heavy traffic no further maintenance

No reflective cracking in the AC from the underlying slab joints & cracks

HaTelit® Asphalt reinforcement geogrid

Old concrete slabs

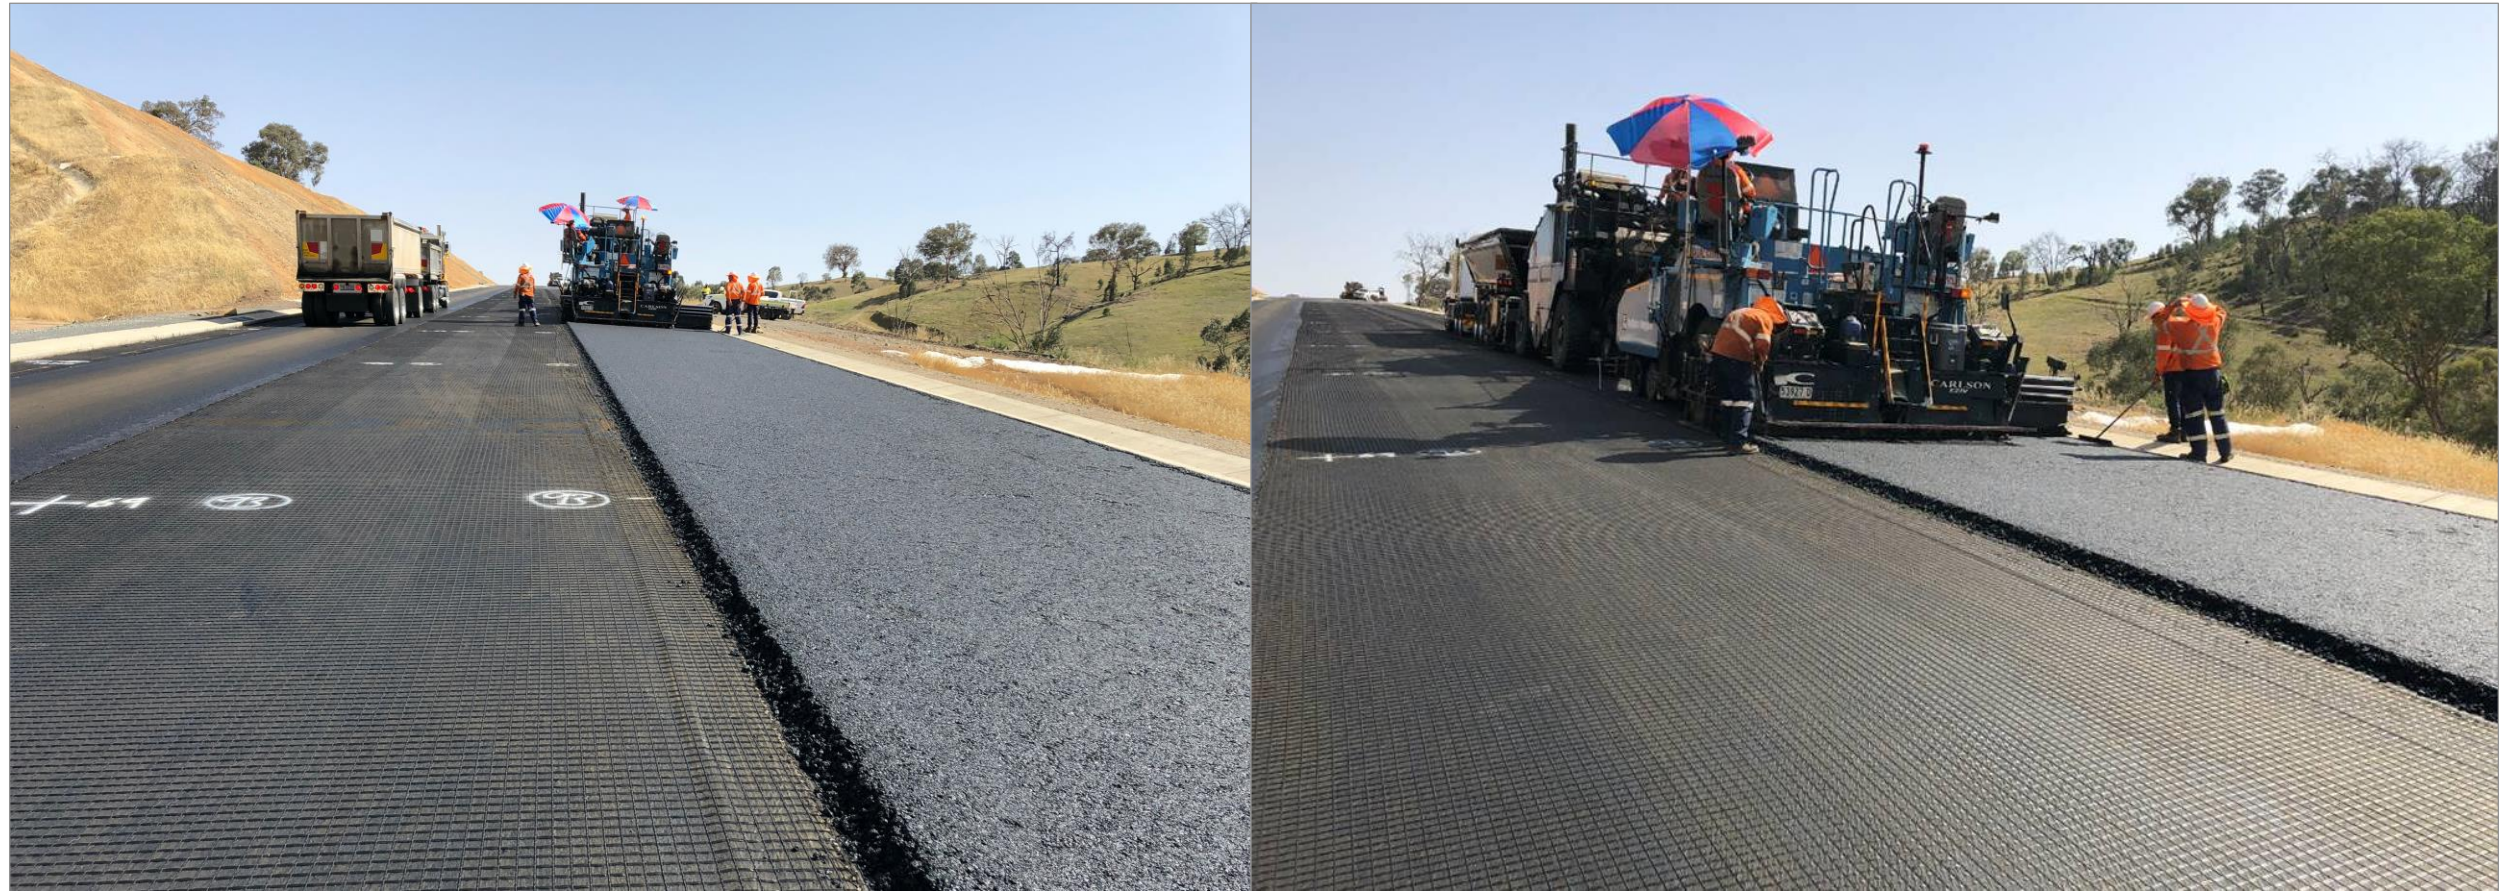
Heavy vehicle roads: New construction CTB & HaTelit C

HaTelit C between two 50mm AC layers, over new CTB

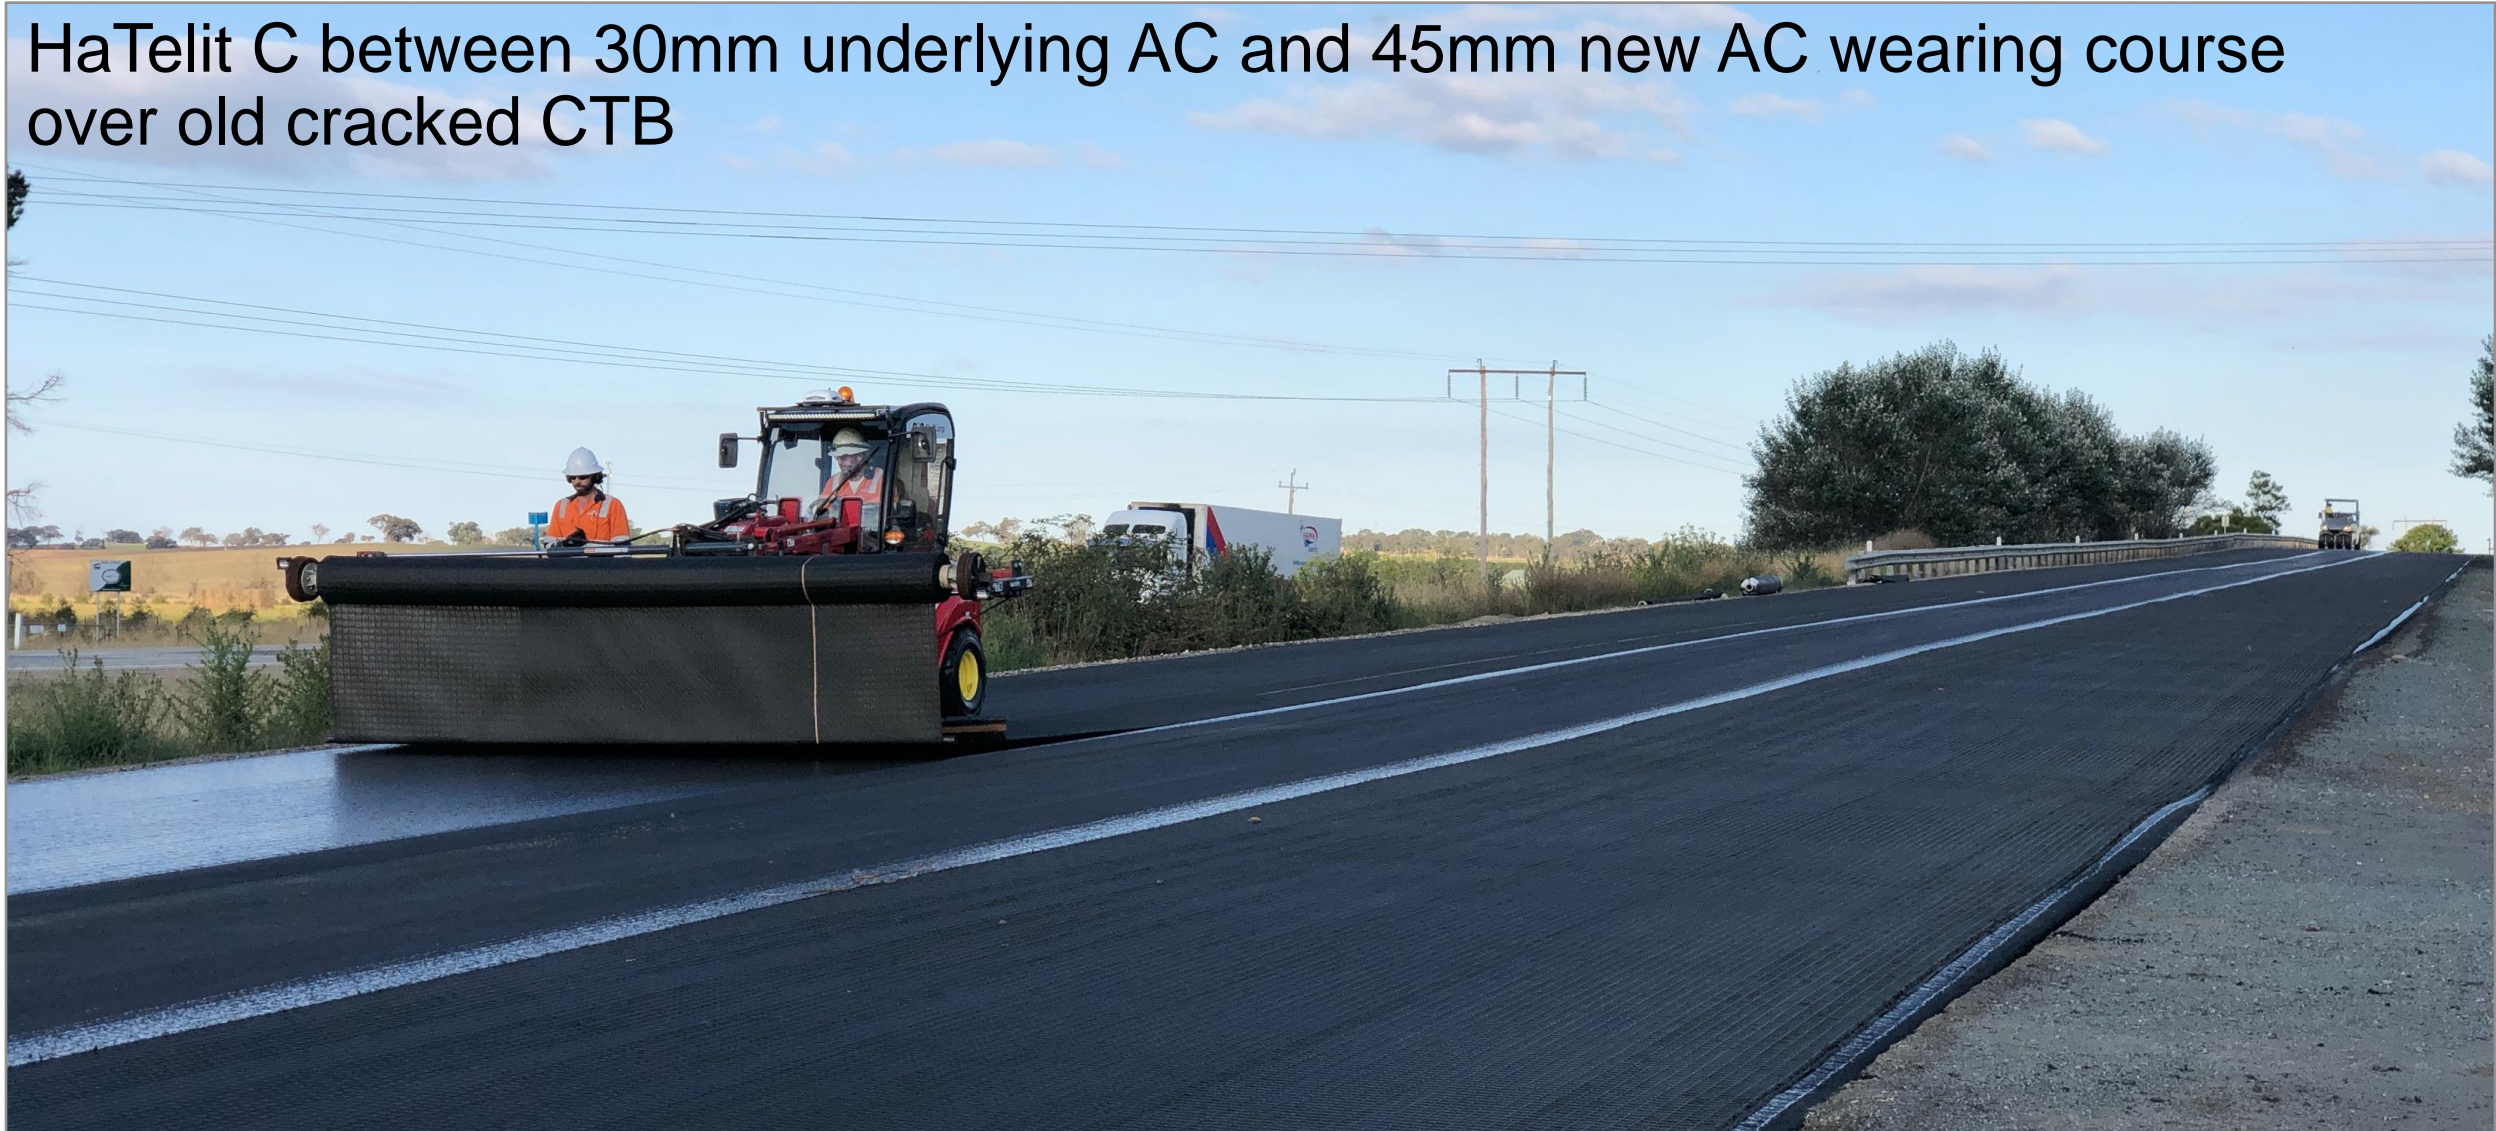
Highways: Rehab – Mill & fill over old CTB using HaTelit C

HaTelit C between 30mm underlying AC and 45mm new AC wearing course over old cracked CTB
